PROSTHETIC SANITIZER AND DEODORIZER

ANDREW BERTRAM, AARON FREIS, JENNA SPAETH, JASON THAM

SILICONE DEGRADATION TEST

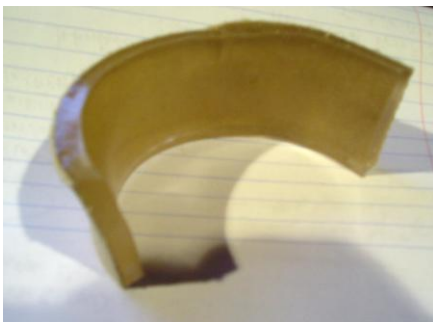
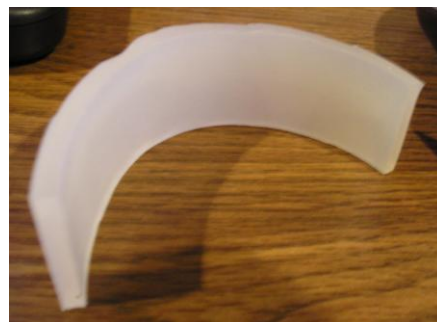
Figure 1 and 2 respectively: ALPS (tan) liner and Freedom Innovations (white) liner.

The prosthetic liner from ALPS Corporation had an outer tan fabric shell connected to 1/4" of silicone material (*Figure 1*). The liner received for Freedom Innovations was a white Parydonn liner approximately 1/8" thick (*Figure 2*). In comparison, both liners were made of silicone; however, each a slightly different kind.

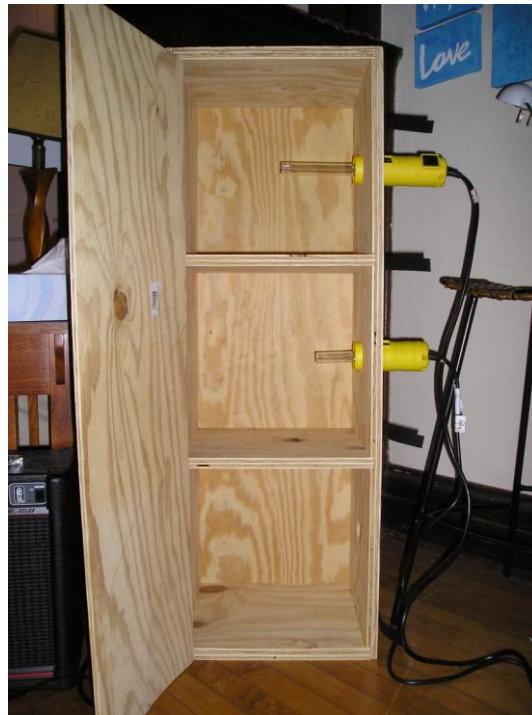
Figure 3: Experimental set-up of degradation test.

UV-irradiation is harmful to both eyes and skin. In order to reduce the risk of physical damage, a wooden testing device was constructed to allow individual testing spaces to prevent light leakage into the environment. During initial construction, three separate enclosures were included in the design, representing the three wattages of ultraviolet light bulbs Dr. Allen provided, 9-watt, 5-watt, and 3-watt. However, due to an inconsistent luminosity and irregular socket requirements, the 3-watt bulb was pulled from the degradation testing. See *Figures 3 and 4* for experimental set-up and lights used.

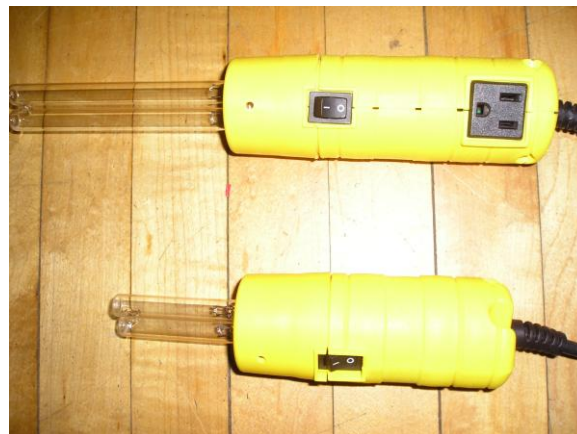
Figure 4: 9-watt UV light (top) and 5-watt UV light (bottom) used for testing.

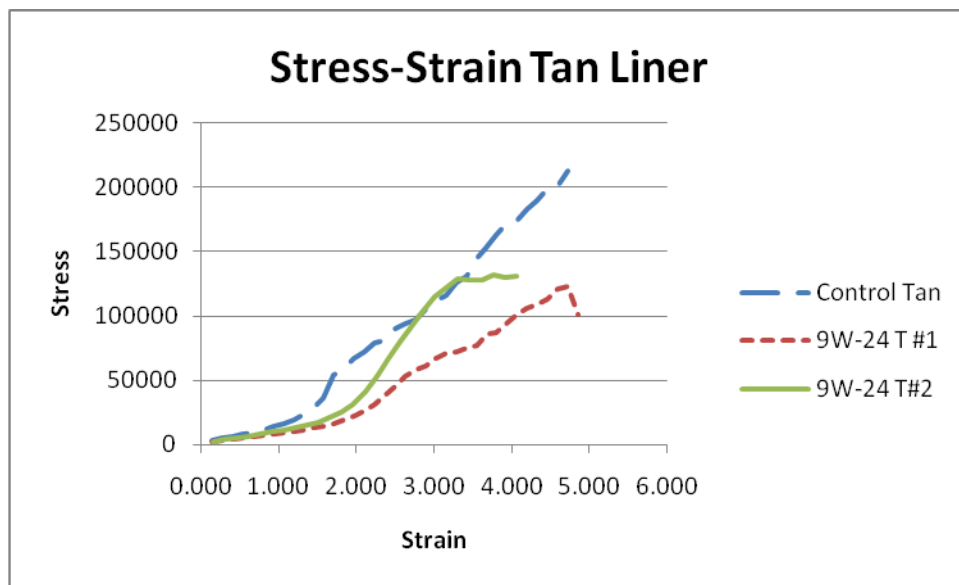
Figure 6: Stress-strain curve for the ALPS (tan) liner; Control versus 9-watt-24 hours.

The following stress-strain graphs were yielded with the aforementioned analysis. *Figure 6* represents the stress-strain curve for the ALPS Corporation (tan) liner, for both the control and 9-watt, 24-hour exposed liner. As the graph shows, there is variation between the maximum failure stress (last point on each data set) and the slope of each of the data sets. The exposed liners have a smaller maximum failure stress versus the control. Relative elasticity, or slope of each line, is inconclusive from these results.

During testing, the ALPS (tan) liner was able to stretch at least six times its original length and for all samples inevitably failed on the fabric portion. The variability in the stress-strain curve represents this occurrence. It is also apparent that the two liners exposed for the same amount of time are inconsistent with each other, questioning the consistency of the difference from the control.

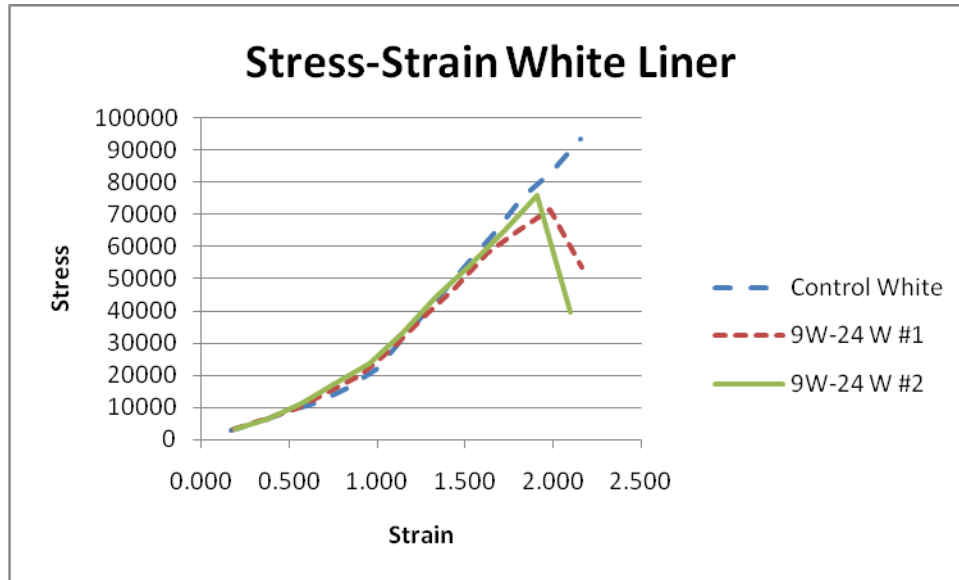
Figure 7: Stress-strain curve for the Freedom Innovations (white) liner; Control versus 9-watt-24 hours.

Figure 7 represents the stress-strain curve of the Freedom Innovations (white) liner. The elasticity and relative strength of this silicone material stayed constant after 24 hours of ultraviolet light exposure. The relative strength of the material is also consistent up until very high strains. The Freedom Innovations liner was also able to stretch many times past its original length and tended to fail towards the top of the specimen. From the stress-strain curve it is apparent that the liner did not lose its integrity post-ultraviolet light exposure.
