Therapeutic Exercise Cage for Muscle Development

ME Technical Section

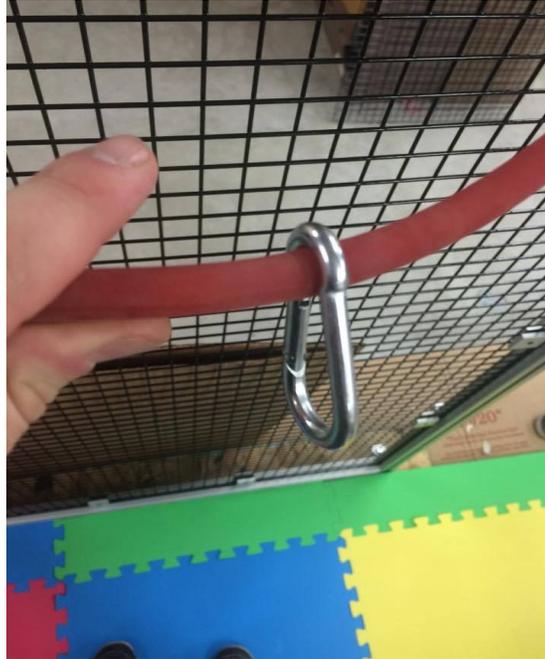
Figure 1: Depiction of carabiner on resistance band ready to attach to the harness.

The second issue was noted after visual inspection of the resistance bands showed that friction between them and the carabiners was starting to cause wear. Since the bands are longer than necessary, each end was connected to the mesh and a carabiner was added in the center to attach to the harness. This setup can be seen in figure 1. The friction between the carabiner and band has begun to wear out the bands. The group plans to address this problem adding makeshift bearings to either the carabiners or the bands themselves. The bearings will prevent direct contact between the bands and carabiners as well as allow for even tension throughout the bands.

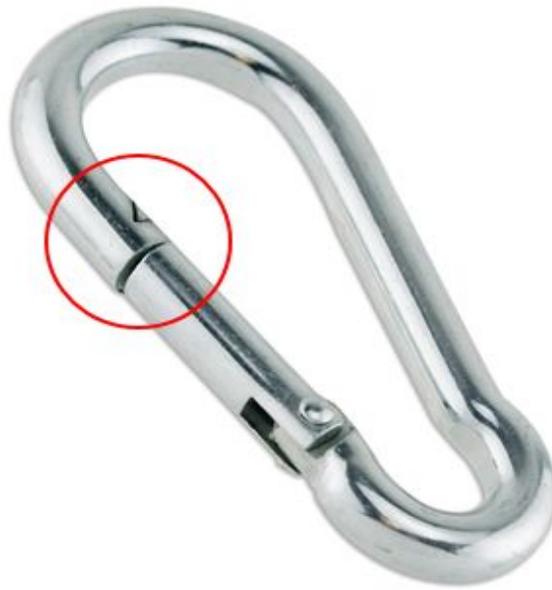
Figure 2: Current carabiners with sharp slots circled in red.

The third issue was observed during the group's statistical mesh testing when the ends of the bands were being attached/detached to the mesh. The carabiners have small slots with sharp edges to ensure they are secure when closed (see figure 2). These sharp edges tend to scrape and cut the mesh coating unless they are attached/detached with caution and knowledge of the issue problem. The wear of the mesh can be seen in figure 3. The group plans to address this issue by either recommending new carabiners or adding an additional coating, possibly made of rubber, to the areas of the mesh that will be used most frequently. Either solution would likely work individually, but the group would like to implement them both.

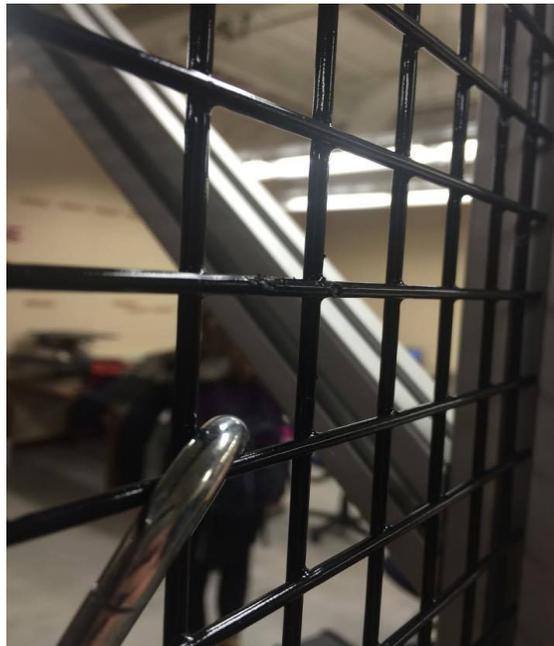
Figure 3: Damaged to mesh from attaching/detaching resistance band carabiners.
